THE WINDOW GLASS AND STAINED GLASS WINDOWS OF BELÉM: A CULTURAL HISTORY OF THE BRAZILIAN AMAZON REGION

Amanda Corrêa Pinto, Márcia Vilarigues, Thais Sanjad

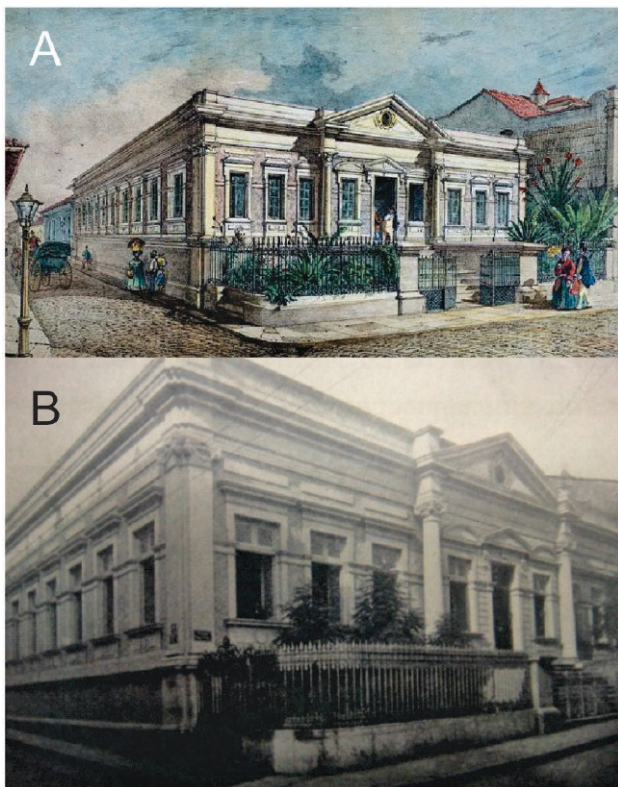
Fig. 2: Record of the transition of the window in the same building: a) Lithography depicting the Commercial Bank, with wooden shutters, in 1867. © Centro de Memória da Amazônia. Author: Joseph Léon Righini; b) Pará State Public Archive, with flat glass in 1899. Author: Augusto Fidanza.

It was only in the second half of 19th century that the wooden windows of prominent buildings, such as churches and government offices, began being replaced by flat glass (figure 2). This is also when the first stained glass windows were commissioned from Europe. Due to their high cost, these windows were a symbol of luxury and power.

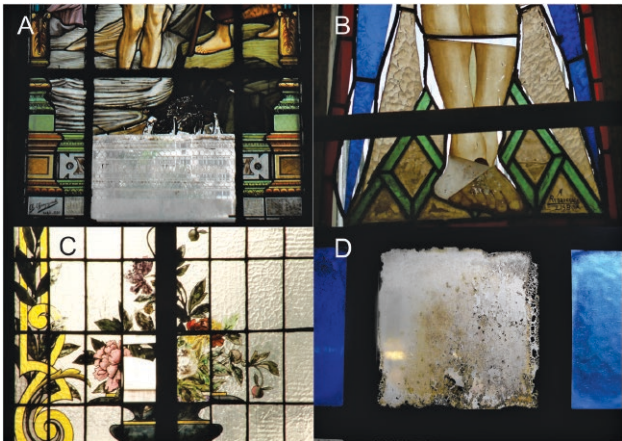
Fig. 3: Examples of damage found on stained glass windows in Belém: a) Detachment of painting – BSN; b) Physical damage to the lead casing – Britto Pontes Mausoleum; c) Missing pieces and inadequate repairs – MEP; d) Thick layer of microorganisms – Assis Chermont Mausoleum. Photographs: Corrêa Pinto.A. Corrêa Pinto.

Despite having been adopted in architectural designs only very recently, the city's flat glass windows often present signs of deterioration (figure 3), such as iridescent smudges, opacity or cracks, and the solution for this damage has invariably to discard the original pieces. Sometimes, not only the glass, but also the whole casing is replaced, altering the characteristics of the building and accentuating the loss of its historical value.

In the specific case of stained glass windows, the painting becomes detached in some pieces, while in others, physical damage to the lead comes also causes the glass to crack (figure 3a). Other problems include the loss of some pieces, inadequate repairs, and the development of biofilms. These problems, especially the latter one, are exacerbated by the extreme local climatic conditions, given the proximity of Belém to the equator, with constant high temperatures (27–35° C) and relative humidity (45–90 %), and frequent, intense rainfall.
